# Gorkha Valley Assessment, Nepal

Gorkha District, June 2015

**The Situation Overview outlines the humanitarian needs among the residents living in hard-to-reach areas of the specific District of Gorkha, situated northwest of Kathmandu.**

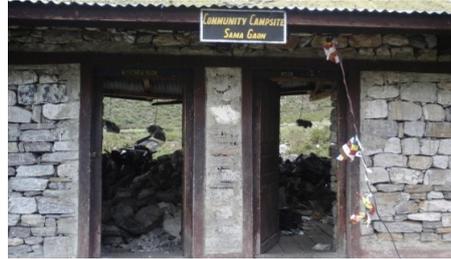
**Picture 1: Damaged community campsite in Samagaon VDC**

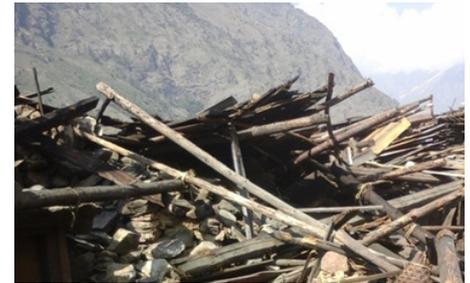
Houses in Sipchet were constructed of either mud-bonded brick/stone with thatch/straw roofing, or wood plank walls with wood plank roofing. There, 100% of houses were damaged during the first earthquake.

Poor building design, poor construction practices and neglect in keeping the houses in good condition were the top three reasons given as main causes of housing damage in all three communities.

**Picture 2: Completely destroyed home in Sipchet Ward 2**

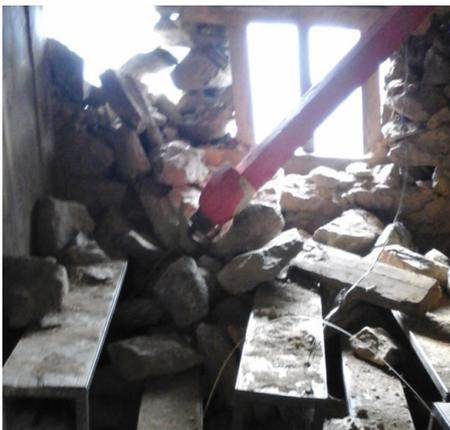
Picture 3: Damaged primary school in Lokpa VDC

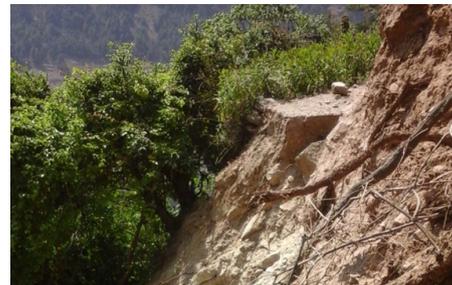
Access was a primary concern expressed in all assessed VDCs. All seven VDCs in northern Gorkha District were reportedly typically inaccessible by vehicles. Instead, settlements were connected by trails and accessible only by foot or with pack animals. Since the earthquakes, active landslides, particularly in the eastern VDCs, have made passage on trails hazardous if at all possible. In other cases, landslides, mudslides and rock fall have damaged or blocked routes.

**Picture 4: Impassable trail to Sipchet**

Chumchet VDCs, access is possible by helicopter only. Communities remain fearful of movement given the risk of landslides. A combination of fear and hazardous access has led to low attendance rates despite reports that some schools have resumed operations.
