Sindhupalchok Valley Assessment, Nepal

Sindhupalchok District, June 2015

SITUATION OVERVIEW

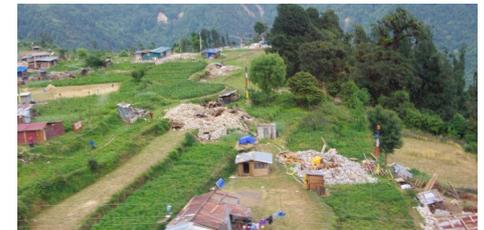
- mud-bonded brick or stone with tile, slate or corrugated galvanised iron (CGI) roofing (Baramchi VDC);
- stone and mud masonry with slate roofing (Golche VDC)
- mud-bonded brick masonry with CGI roofing and some wood plank constructions (Helambu VDC)

A large majority of these houses have been damaged during the first earthquake in Baramchi and Golche VDCs (respectively 75% and 100%). In Golche VDC, poor building design and low quality materials were the top reasons given as main causes of housing damage.

Picture 1: Destruction of houses in Melamcheegaun

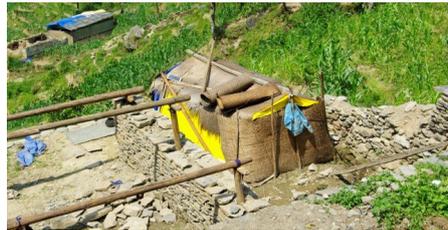
Picture 2: Emergency shelter in Golche Village (Golche VDC)

Temporary shelters in both VDCs have primarily been constructed from tarpaulins and plastic sheeting, with additional wood planks also used in Helambu VDC.

All assessed communities reported needing better roofing and wall materials. Communities in Helambu VDC additionally reported needing access to tools for the construction of temporary shelters, while the ones from Golche VDC were more interested in for information related to safer construction techniques.

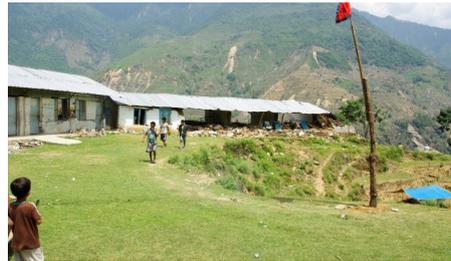
In Golche VDC, all public services – including schools, health centres and municipal service facilities – were reported to be inaccessible due to physical constraints.

Picture 3: School severely damaged after the earthquakes in Golche Village (Golche VDC)

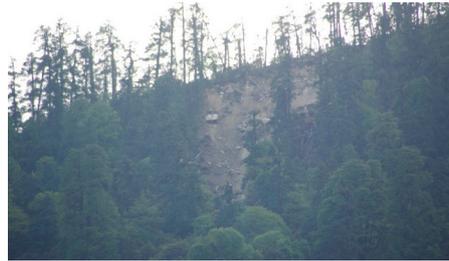
The earthquakes triggered numerous landslides along the road that connects the villages from the south to the north of the Valley, which is now entirely inaccessible.

Picture 4: Landslide over Golche Village

Access could be restored by removing the landslide deposits. However, assistance will likely need to be provided by helicopter (see Annex 1).
